Shoreline Classification of Sebago Lake

Sebago Lake, Maine

Open-File No. 98-123

1998

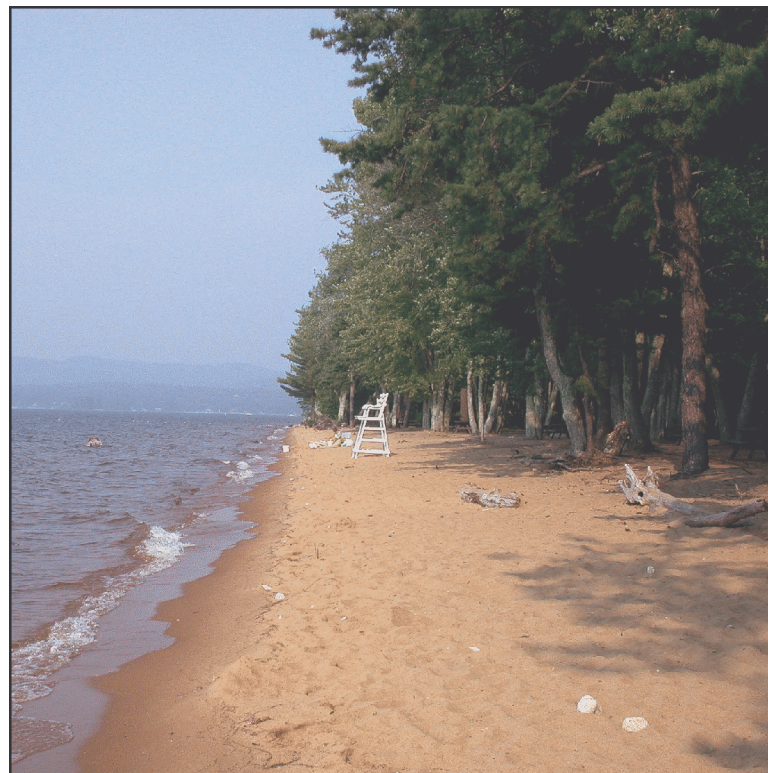
Sand Beach. Sandy sediments that can extend from above the high water mark to hundreds of feet offshore. Composed of fine- and coarse-grained sand, beaches are the most erodible environments found along the shore and vary in width due to slopes and lake level.

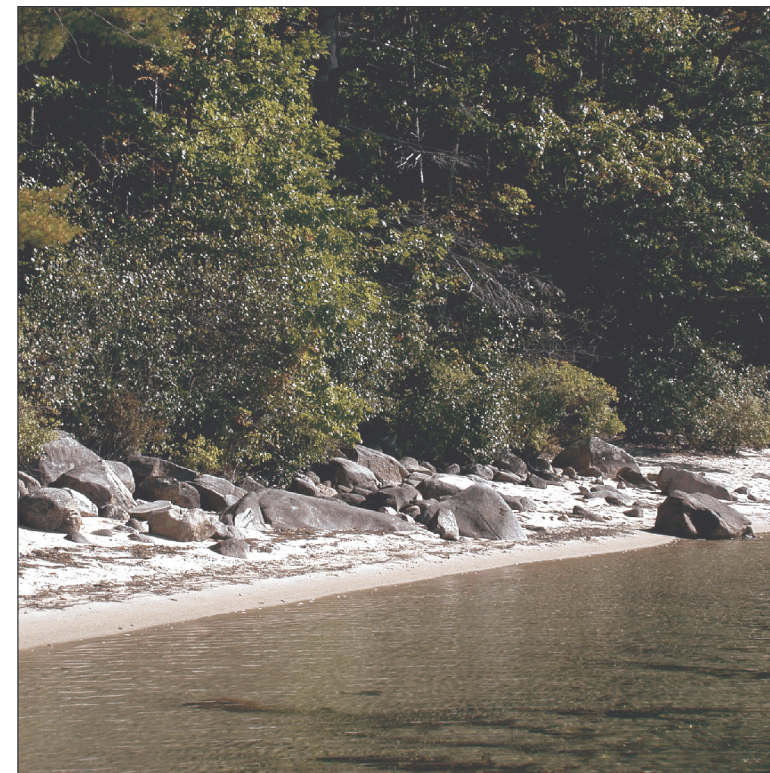
Sand beach with boulders. Sand is both fine- and coarse-grained and forms low ridges, mounds, or flat sloping surfaces. Sand is easily eroded by waves while boulders are more resistant.

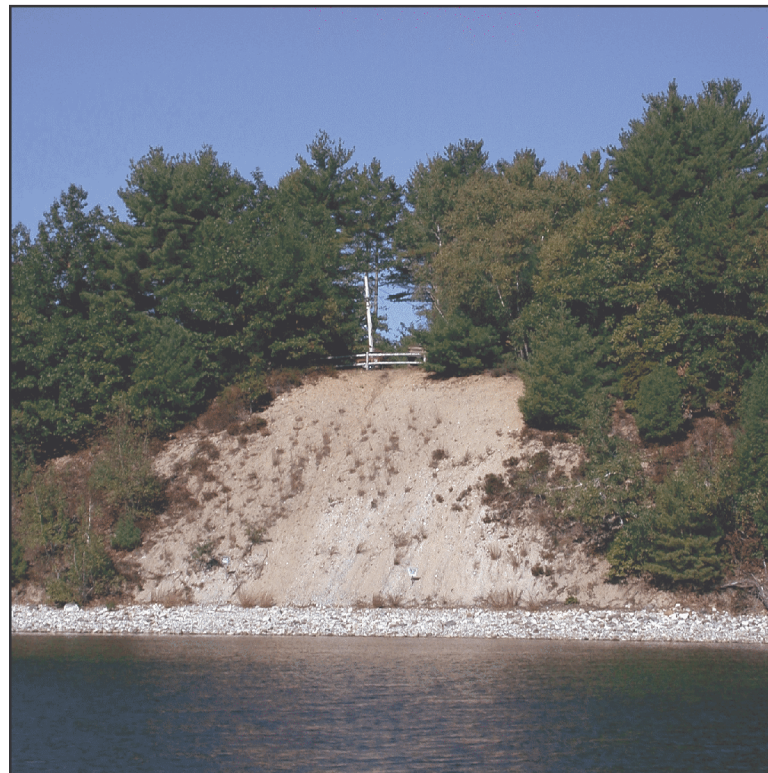
Bluff with an unvegetated or slightly vegetated bluff face. Sandy sediments on the bluff face are exposed and boulders lie at the base of the bluff. Vegetated bluffs are generally stable while unvegetated bluffs are commonly eroding.

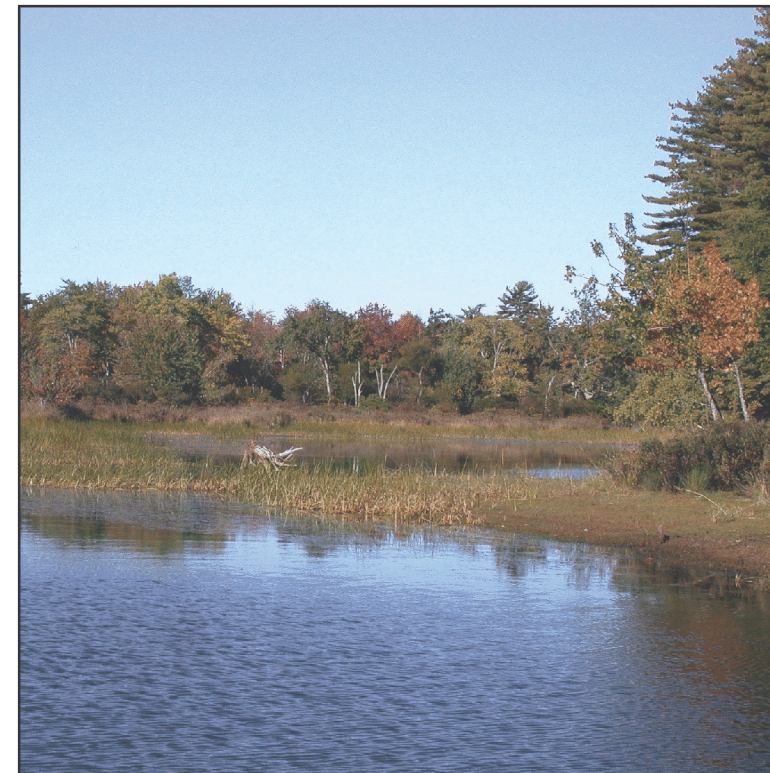
Freshwater Marsh. Low-lying vegetated area composed of an abundance of fine-grained silt, clay, and organics from marsh plants. Marshes often reduce wave energy along the upland shore and have slow erosion rates.

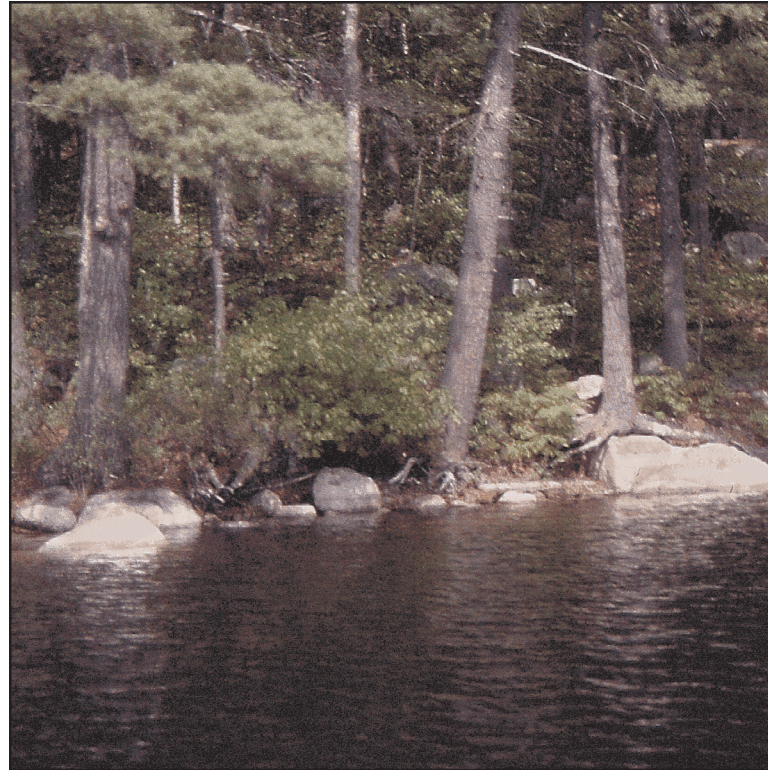
Till. Heterogeneous mixture of sand, silt, clay, and gravel. Unit generally overlies bedrock and is fairly resistant to erosion due to a boulder armor that waves cannot move.

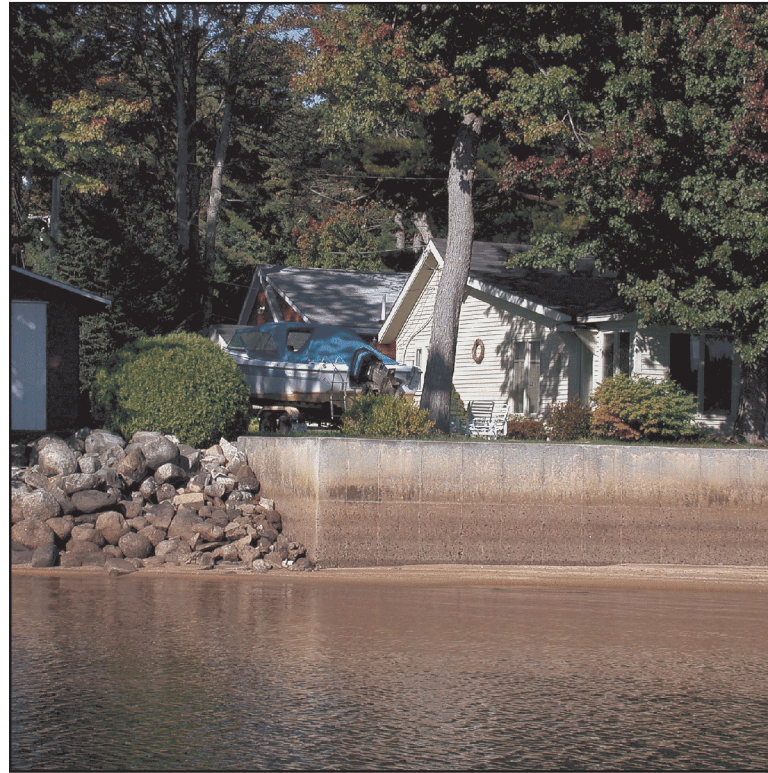
Seawall landward of a sand and/or gravel beach shoreline. Sebago Lake's seasonal 4.5 foot water level fluctuations often covers the beach and waves impact and reflect off portions of the seawalls. Wave reflection leads to beach lowering.

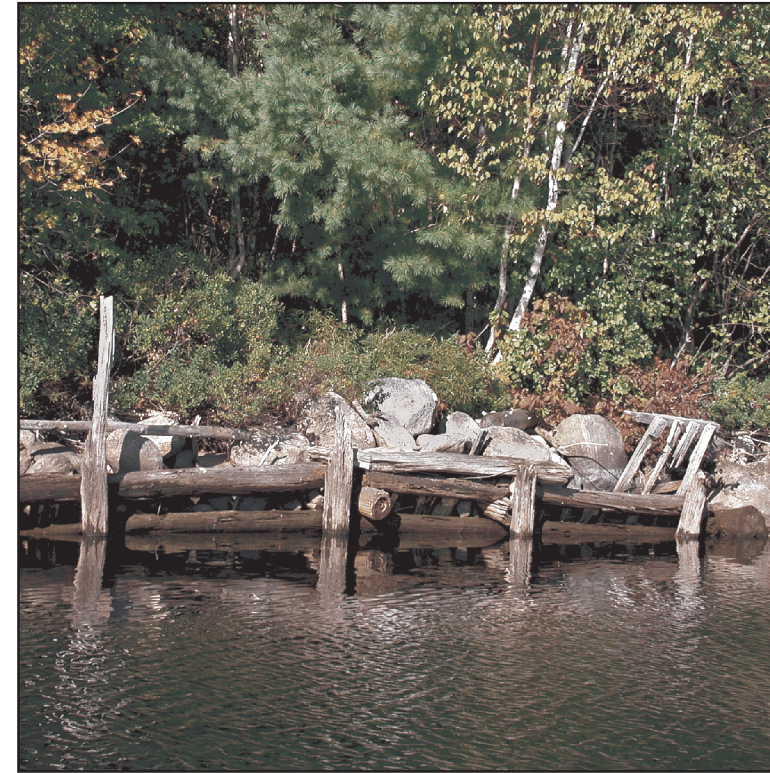
Artificial Fill. Introduced fill material, commonly concrete, riprap, or similar sized rocks. Fairly resistant to erosion, however older solid structures are subject to subsidence, cracking, and disintegration over time.

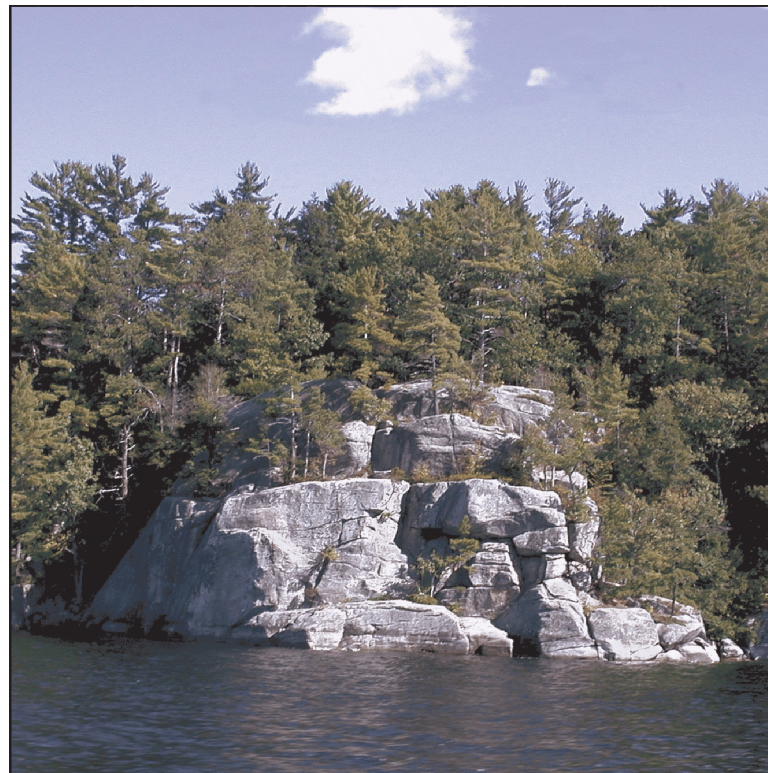
Bedrock or Ledge. Massive units of either granite or metamorphic rock. Very resistant to erosion. May be low-lying or form vertical cliffs.
